# CASE STUDY

## Low Energy Whole House Refurbishment

### Mid-terraced house, Doncaster

A low cost 'whole house' low energy refurbishment - 1890's Victorian mid terrace to current energy standards.

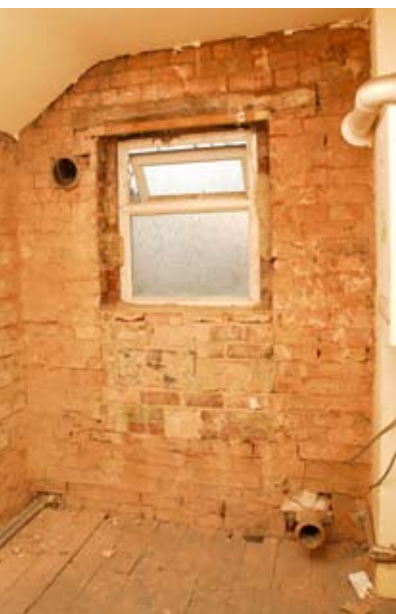
Fig 1

Figure 1 shows Stage 1 with all fixtures removed and the plaster removed back to the original 225mm thick brickwork, although in most cases the EcoStuds would be affixed through the existing plasterwork.

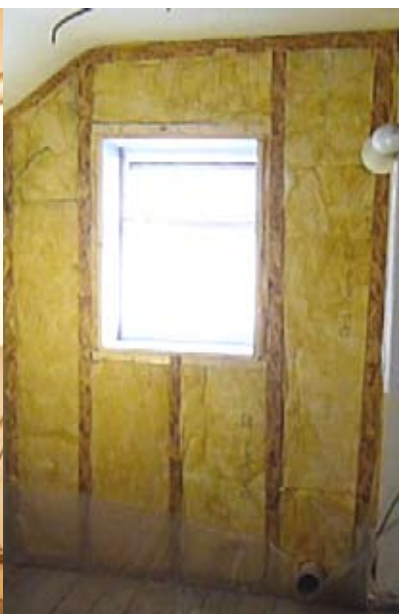
Fig 2

Figure 2 shows Stage 2 with the new EcoStud mechanically fixed to the brick wall and 75mm of EcoBatt friction fitted between to ensure a complete coverage of insulation across the whole wall.

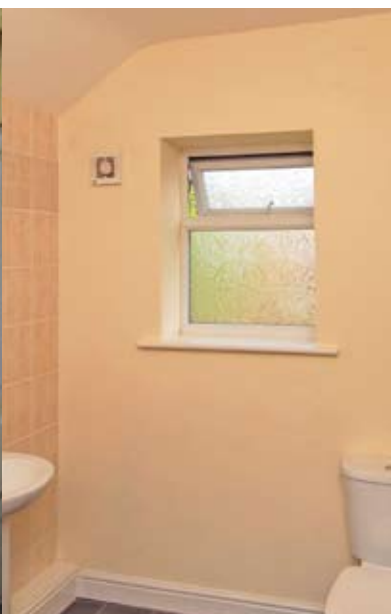
Fig 3

Figures 3 and 6 show Stage 3 with the 12.5mm vapour check plasterboard fixed to the EcoStud framework in the bathroom and the living room. The overall reduction in floor area was less than 2 per cent.

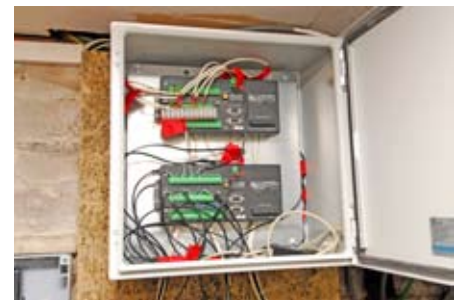
Fig 8

HoBo type sensors were used in each room to measure the internal conditions as well as installing an external HoBo sensor to monitor weather conditions. Figure 8 below shows the set up of the data logger.

and internal face of the solid wall. Permanent in-situ sensors have been installed in each room to measure relative humidity and temperature and this data is collected in a logger located in the cellar. University College London will work with Knauf Insulation over coming years to measure and interpret the results generated. Sensors were also positioned within the suspended timber ground floor zone and on the cellar wall.
